Single Survey

15 The Terrace Reay Thurso Caithness KW14 7RQ

survey report on :

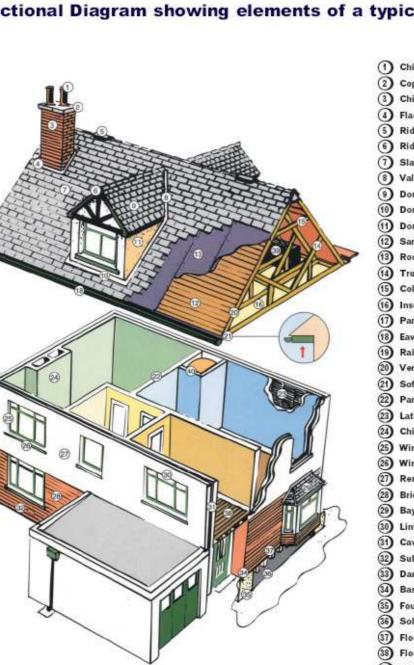
Sectional Diagram showing elements of a typical house

Reference may be made in this report to some or all of the above component parts of the property. This diagram may assist you in locating and understanding these items.
