## Single Survey

**Rowan Garth**  
**Stirkoke**  
**Wick**  
**Caithness**  
**KW1 5SG**

survey report on :

<b>Customer</b>	Mr Ronald Innes
<b>Customer Address</b>	Rowan Garth Stirkoke Wick Caithness KW1 5SG
<b>Date of Inspection</b>	19 <sup>th</sup> September 2017
<b>Prepared by</b>	Keith Bowman BSc MRICS Registered Valuer

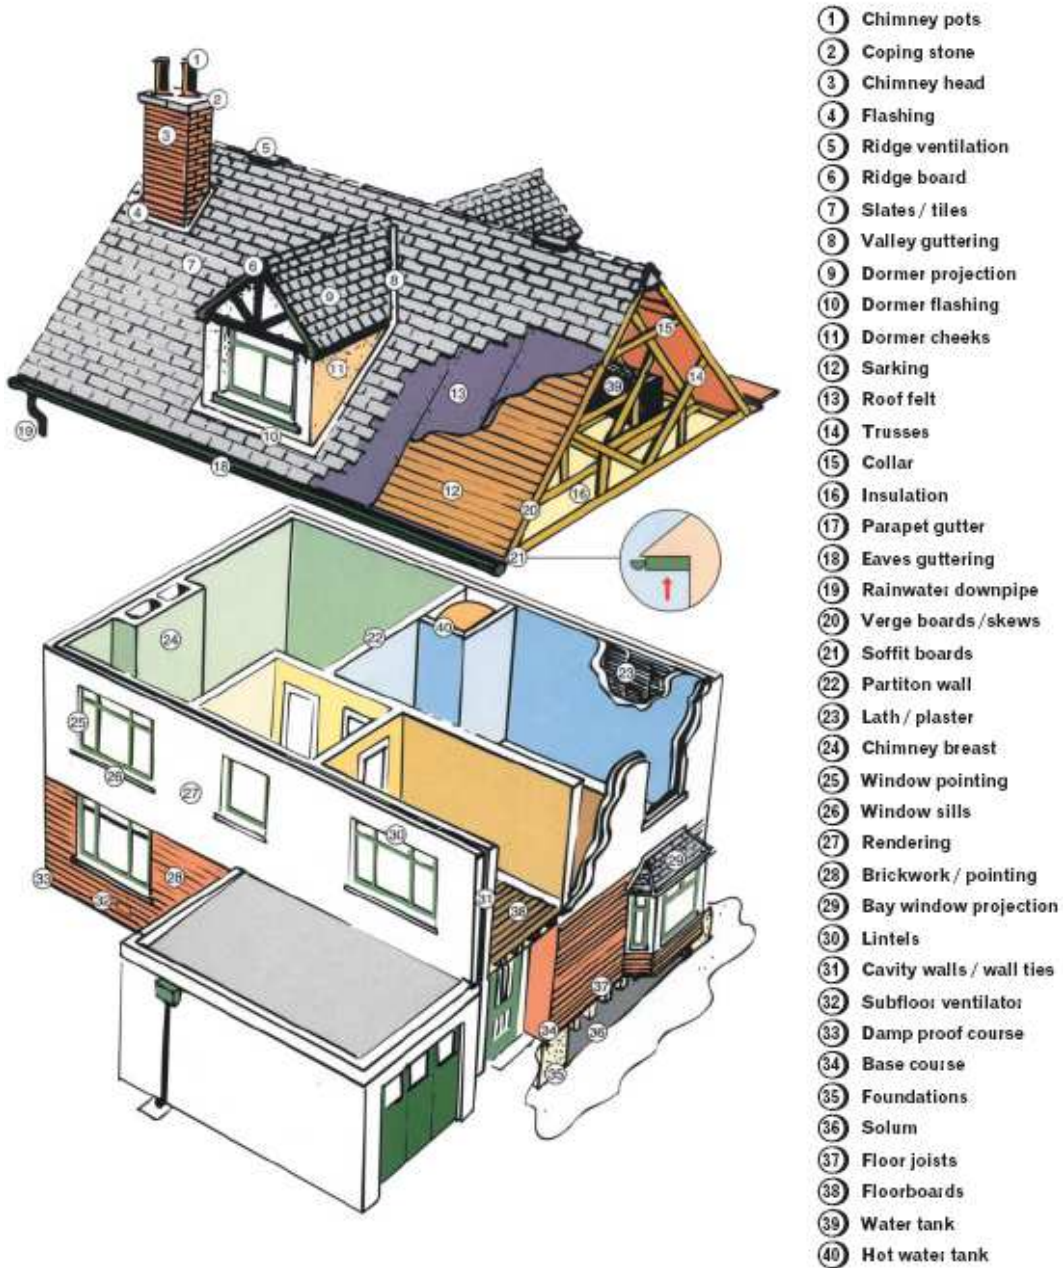
**Sectional Diagram showing elements of a typical house**

Reference may be made in this report to some or all of the above component parts of the property. This diagram may assist you in locating and understanding these items.

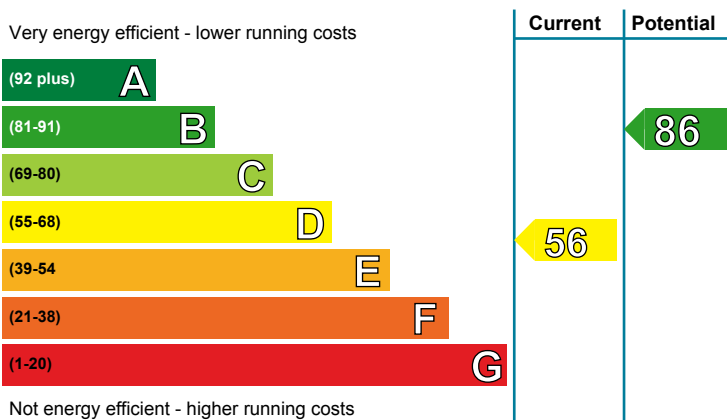
## Energy Efficiency Rating

This graph shows the current efficiency of your home, taking into account both energy efficiency and fuel costs. The higher this rating, the lower your fuel bills are likely to be.

Your current rating is **band D (56)**. The average rating for EPCs in Scotland is **band D (61)**.

The potential rating shows the effect of undertaking all of the improvement measures listed within your recommendations report.

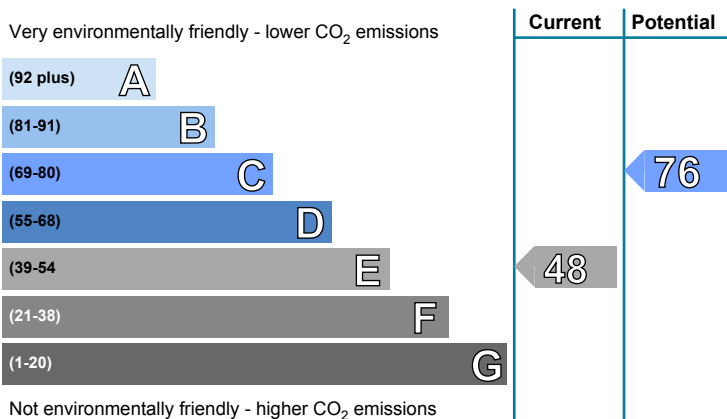
## Environmental Impact (CO<sub>2</sub>) Rating

This graph shows the effect of your home on the environment in terms of carbon dioxide (CO<sub>2</sub>) emissions. The higher the rating, the less impact it has on the environment.
