Single Survey

**Windybrae
Bower
Wick
Caithness
KW1 4TT**

Customer	Mr & Mrs Shearer
Customer Address	Windybrae Bower Wick Caithness KW1 4TT
Date of Inspection	31 st August 2017
Prepared by	Keith Bowman BSc MRICS Registered Valuer

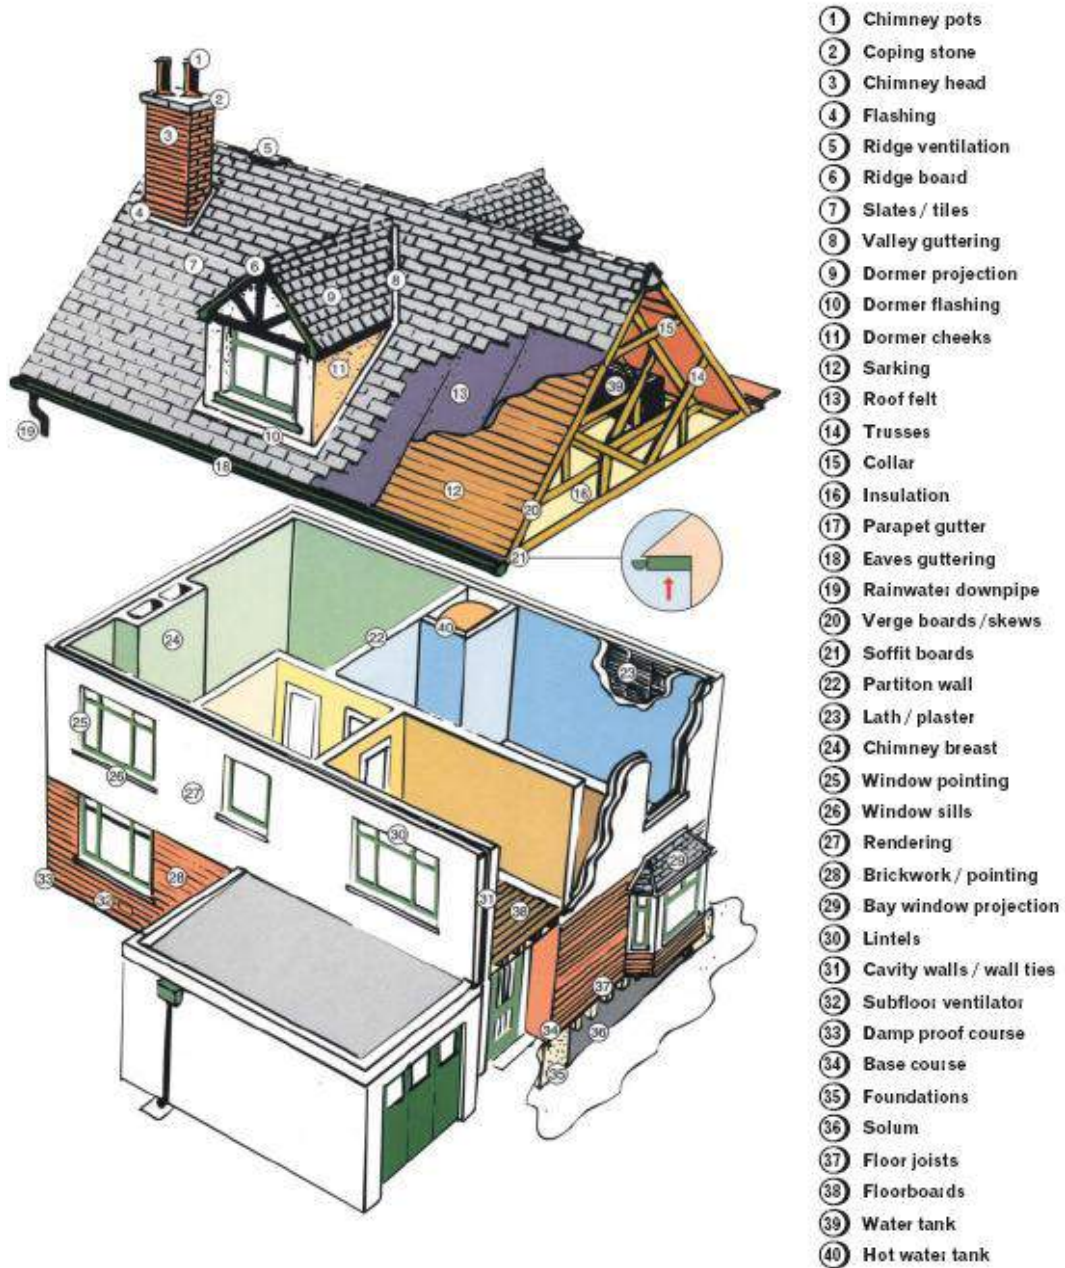
Sectional Diagram showing elements of a typical house

Reference may be made in this report to some or all of the above component parts of the property. This diagram may assist you in locating and understanding these items.
