## Single Survey

**10 Dunnet Road  
Thurso  
Caithness  
KW14 8HY**

<b>Customer</b>	Cairn Housing Association
<b>Customer Address</b>	Caroline MacAskill House 30 Waterloo Place Inverness IV1 1NB
<b>Date of Inspection</b>	15 <sup>th</sup> August 2017
<b>Prepared by</b>	Keith J Bowman BSc MRICS Registered Valuer

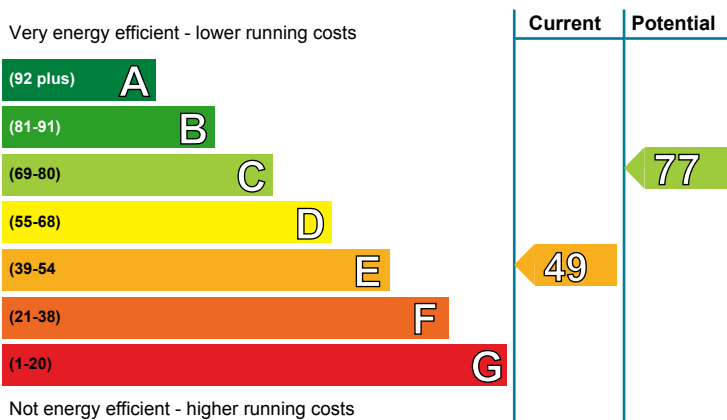
## Energy Efficiency Rating

This graph shows the current efficiency of your home, taking into account both energy efficiency and fuel costs. The higher this rating, the lower your fuel bills are likely to be.

Your current rating is **band E (49)**. The average rating for EPCs in Scotland is **band D (61)**.

The potential rating shows the effect of undertaking all of the improvement measures listed within your recommendations report.

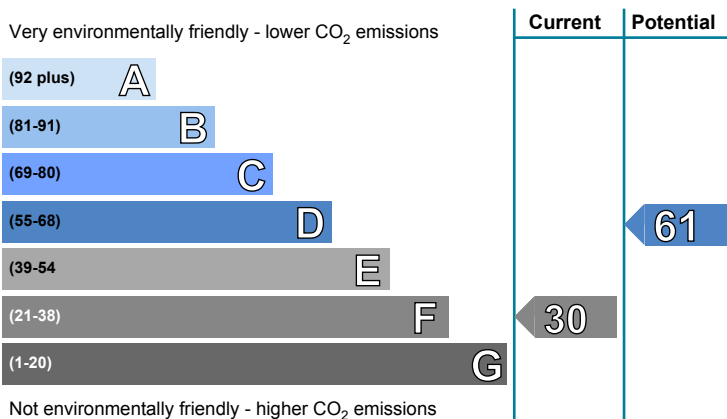
## Environmental Impact (CO<sub>2</sub>) Rating

This graph shows the effect of your home on the environment in terms of carbon dioxide (CO<sub>2</sub>) emissions. The higher the rating, the less impact it has on the environment.
