HOME REPORT

122 TOTIGAN
STRATHY POINT, STRATHY
THURSO
KW14 7RY

ENERGY PERFORMANCE CERTIFICATE

SINGLE SURVEY

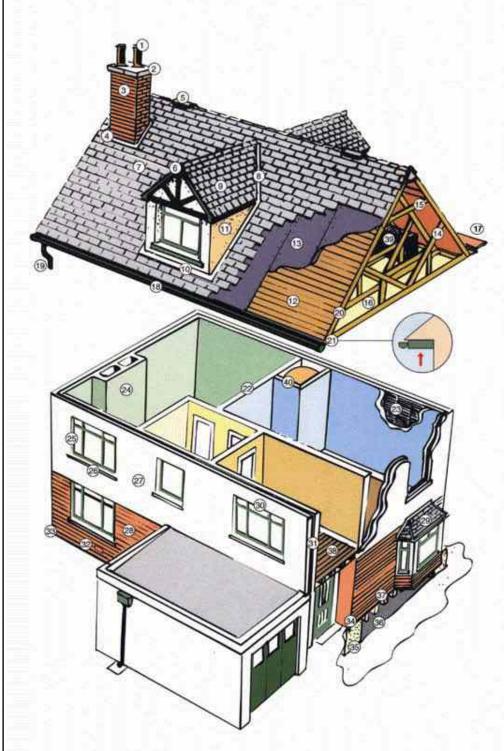
Sectional Diagram showing elements of a typical house

Reference may be made in this report to some or all of the above component parts of the property. This diagram may assist you in locating and understanding these items.

- 1 Chimney pots
- 2 Coping stone
- 3) Chimney head
- 4) Flashing
- (5) Ridge ventilation
- 6) Ridge board
- 7) Slates / tiles
- (8) Valley guttering
- 9) Dormer projection
- 10 Dormer flashing
- 11 Dormer cheeks
- 12) Sarking
- 13) Roof felt
- (14) Trusses
- 15) Collar
- (16) Insulation
- 7) Parapet gutter
- 18) Eaves guttering
- (19) Rainwater downpipe
- 0) Verge boards /skews
- (21) Soffit boards
- 22) Partition wall
- 23) Lath / plaster
- 24) Chimney breast
- (25) Window pointing
- S
- 26) Window sills
- (27) Rendering
- (28) Brickwork / pointing
- 29) Bay window projection
- 30 Lintels
- (31) Cavity walls / wall ties
- 32 Subfloor ventilator
- 33) Damp proof course
- 34) Base course
- 35) Foundations
- 36) Solum
- 37) Floor joists
- 38) Floorboards
- 9) Water tank
- 40) Hot water tank
