# Single Survey

**Lower Houstry  
Halkirk  
KW12 6UJ**

survey report on :

<b>Customer</b>	Mrs Catherine MacLucas
<b>Customer Address</b>	Lower Houstry Halkirk KW12 6UJ
<b>Date of Inspection</b>	14 <sup>th</sup> August 2018
<b>Prepared by</b>	Keith Bowman BSc MRICS Registered Valuer

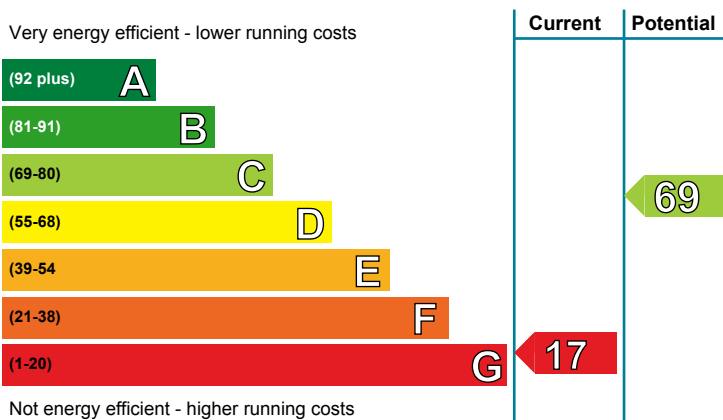
## Energy Efficiency Rating

This graph shows the current efficiency of your home, taking into account both energy efficiency and fuel costs. The higher this rating, the lower your fuel bills are likely to be.

Your current rating is **band G (17)**. The average rating for EPCs in Scotland is **band D (61)**.

The potential rating shows the effect of undertaking all of the improvement measures listed within your recommendations report.
