# HOME REPORT

Lean-Dubh Newtonhill

Wick  
KW1 5SB

# Single Survey

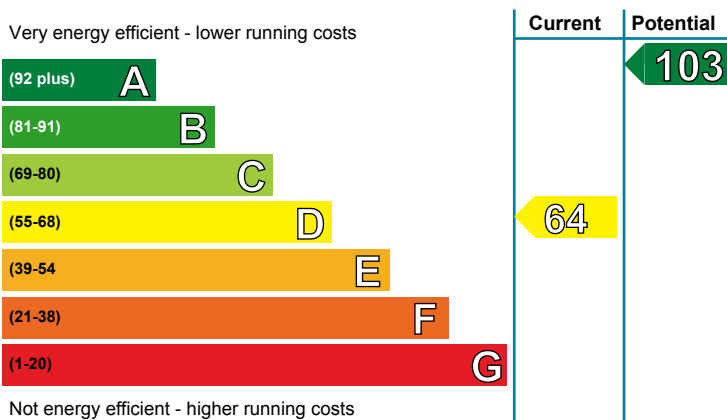
## Energy Efficiency Rating

This graph shows the current efficiency of your home, taking into account both energy efficiency and fuel costs. The higher this rating, the lower your fuel bills are likely to be.

Your current rating is **band D (64)**. The average rating for EPCs in Scotland is **band D (61)**.

The potential rating shows the effect of undertaking all of the improvement measures listed within your recommendations report.

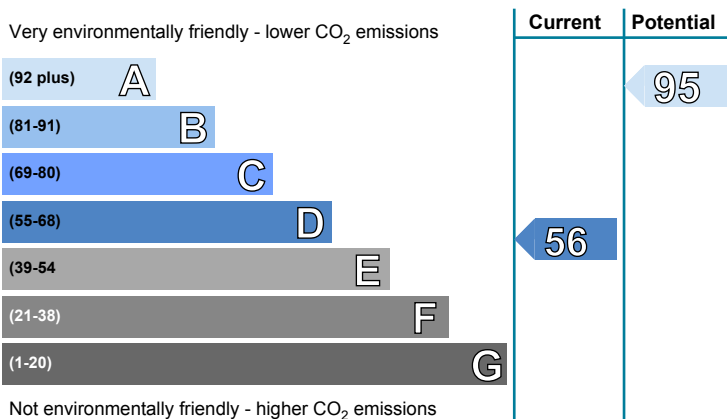
## Environmental Impact (CO<sub>2</sub>) Rating

This graph shows the effect of your home on the environment in terms of carbon dioxide (CO<sub>2</sub>) emissions. The higher the rating, the less impact it has on the environment.

Your current rating is **band D (56)**. The average rating for EPCs in Scotland is **band D (59)**.

The potential rating shows the effect of undertaking all of the improvement measures listed within your recommendations report.
