Single Survey

**5 Munro Place
Bettyhill
Caithness
KW14 7TD**

survey report on :

Customer	Moira Stuart
Customer Address	6 Culloden Road Balloch Inverness IV2 7HQ
Date of Inspection	30 th January 2019
Prepared by	Douglas Gordon BSc (Hons) MRICS Registered Valuer

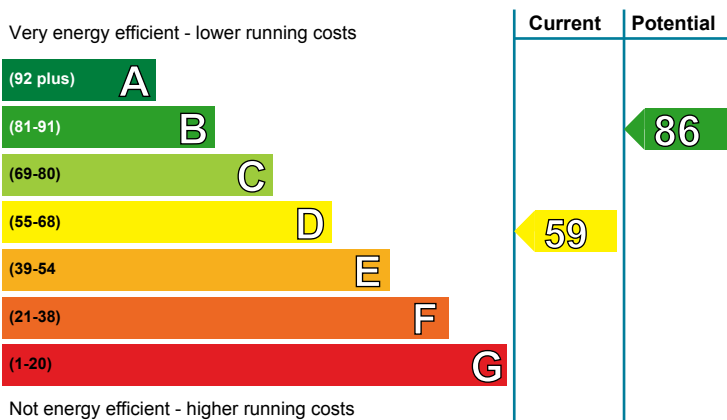
Energy Efficiency Rating

This graph shows the current efficiency of your home, taking into account both energy efficiency and fuel costs. The higher this rating, the lower your fuel bills are likely to be.

Your current rating is **band D (59)**. The average rating for EPCs in Scotland is **band D (61)**.

The potential rating shows the effect of undertaking all of the improvement measures listed within your recommendations report.

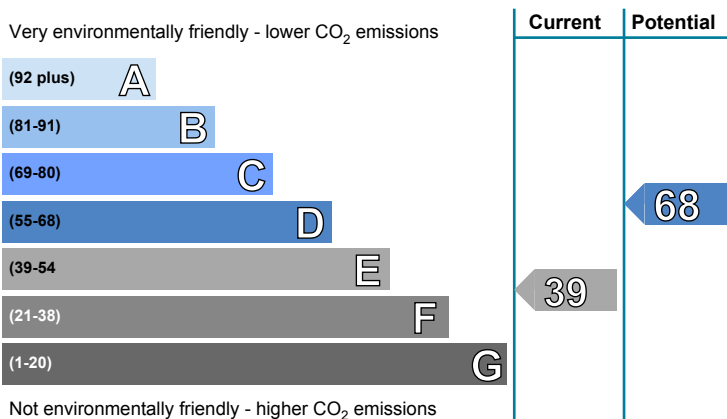
Environmental Impact (CO₂) Rating

This graph shows the effect of your home on the environment in terms of carbon dioxide (CO₂) emissions. The higher the rating, the less impact it has on the environment.
