**SHEPHERD**  
**HOME REPORT**

CRUACHAN WEYDALE

# Energy Performance Certificate (EPC)

# Single Survey

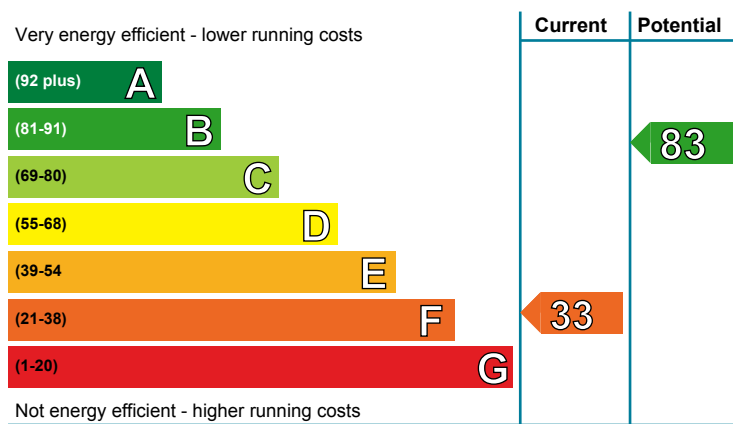
## Energy Efficiency Rating

This graph shows the current efficiency of your home, taking into account both energy efficiency and fuel costs. The higher this rating, the lower your fuel bills are likely to be.

Your current rating is **band F (33)**. The average rating for EPCs in Scotland is **band D (61)**.

The potential rating shows the effect of undertaking all of the improvement measures listed within your recommendations report.

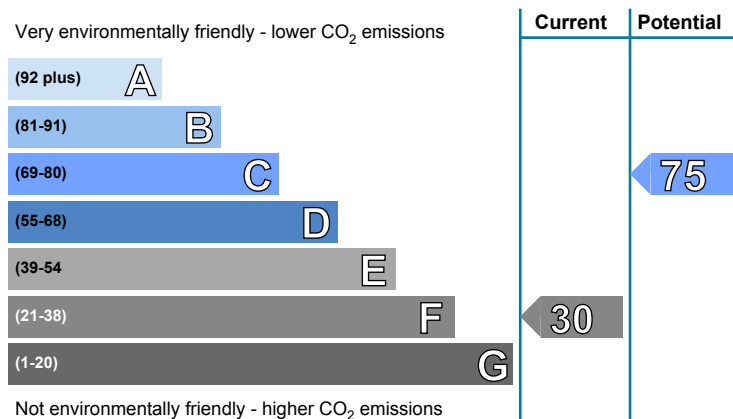
## Environmental Impact (CO<sub>2</sub>) Rating

This graph shows the effect of your home on the environment in terms of carbon dioxide (CO<sub>2</sub>) emissions. The higher the rating, the less impact it has on the environment.

Your current rating is **band F (30)**. The average rating for EPCs in Scotland is **band D (59)**.

The potential rating shows the effect of undertaking all of the improvement measures listed within your recommendations report.
