# HOME REPORT

THORDALE

WEYDALE  
THURSO  
KW14 8YN

# Energy Performance Certificate (EPC)

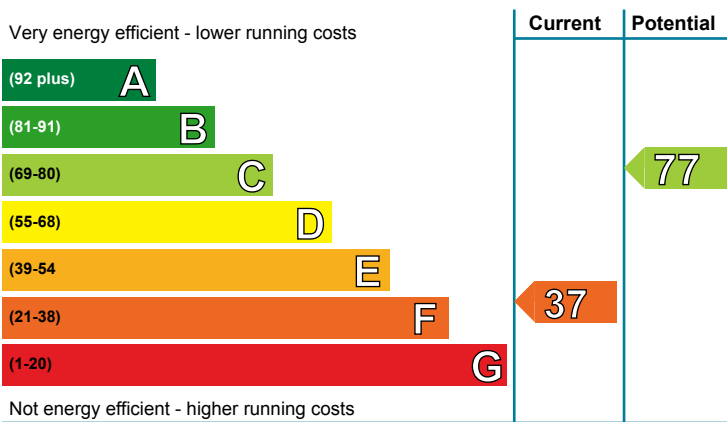
## Energy Efficiency Rating

This graph shows the current efficiency of your home, taking into account both energy efficiency and fuel costs. The higher this rating, the lower your fuel bills are likely to be.

Your current rating is **band F (37)**. The average rating for EPCs in Scotland is **band D (61)**.

The potential rating shows the effect of undertaking all of the improvement measures listed within your recommendations report.

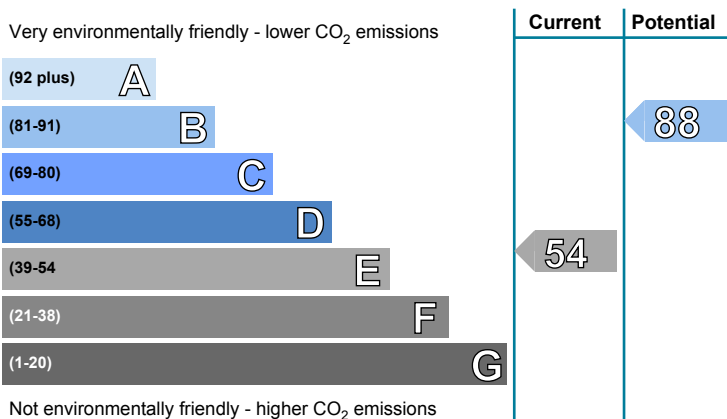
## Environmental Impact (CO<sub>2</sub>) Rating

This graph shows the effect of your home on the environment in terms of carbon dioxide (CO<sub>2</sub>) emissions. The higher the rating, the less impact it has on the environment.

Your current rating is **band E (54)**. The average rating for EPCs in Scotland is **band D (59)**.

The potential rating shows the effect of undertaking all of the improvement measures listed within your recommendations report.
