HOME REPORT

23 CALDER SQUARE
CASTLETOWN
THURSO
KW14 8UP

ENERGY PERFORMANCE CERTIFICATE

Single Survey

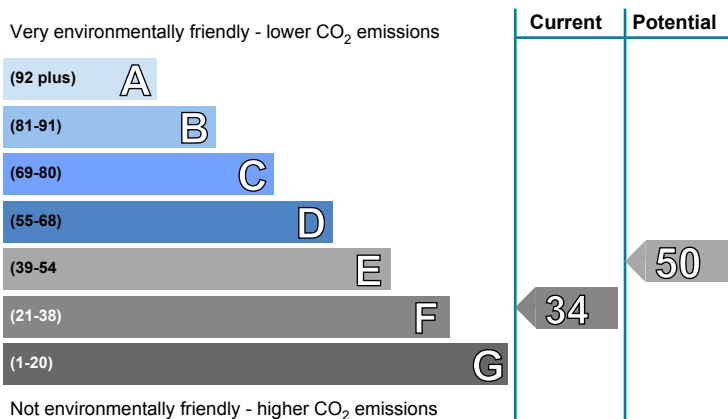
Environmental Impact (CO₂) Rating

This graph shows the effect of your home on the environment in terms of carbon dioxide (CO₂) emissions. The higher the rating, the less impact it has on the environment.

Your current rating is **band F (34)**. The average rating for EPCs in Scotland is **band D (59)**.

The potential rating shows the effect of undertaking all of the improvement measures listed within your recommendations report.
