Single Survey

17 Springpark Terrace Thurso Caithness KW14 8NN

survey report on :

Customer	Miss Caroline Gardaz
Customer Address	17 Springpark Terrace Thurso KW14 8NN
Date of Inspection	15 th December 2020
Prepared by	Keith J Bowman BSc MRICS Registered Valuer

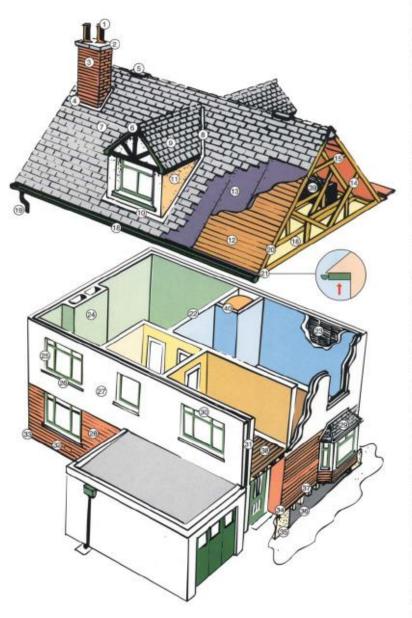
Sectional Diagram showing elements of a typical house

Reference may be made in this report to some or all of the above component parts of the property. This diagram may assist you in locating and understanding these items.
