# Single Survey

**Gilmore  
North Murchison Street  
Wick  
KW1 5HL**

survey report on :

<b>Customer</b>	Michael Miller
<b>Customer Address</b>	
<b>Date of Inspection</b>	24 <sup>th</sup> May 2022
<b>Prepared by</b>	Keith J Bowman BSc MRICS Registered Valuer

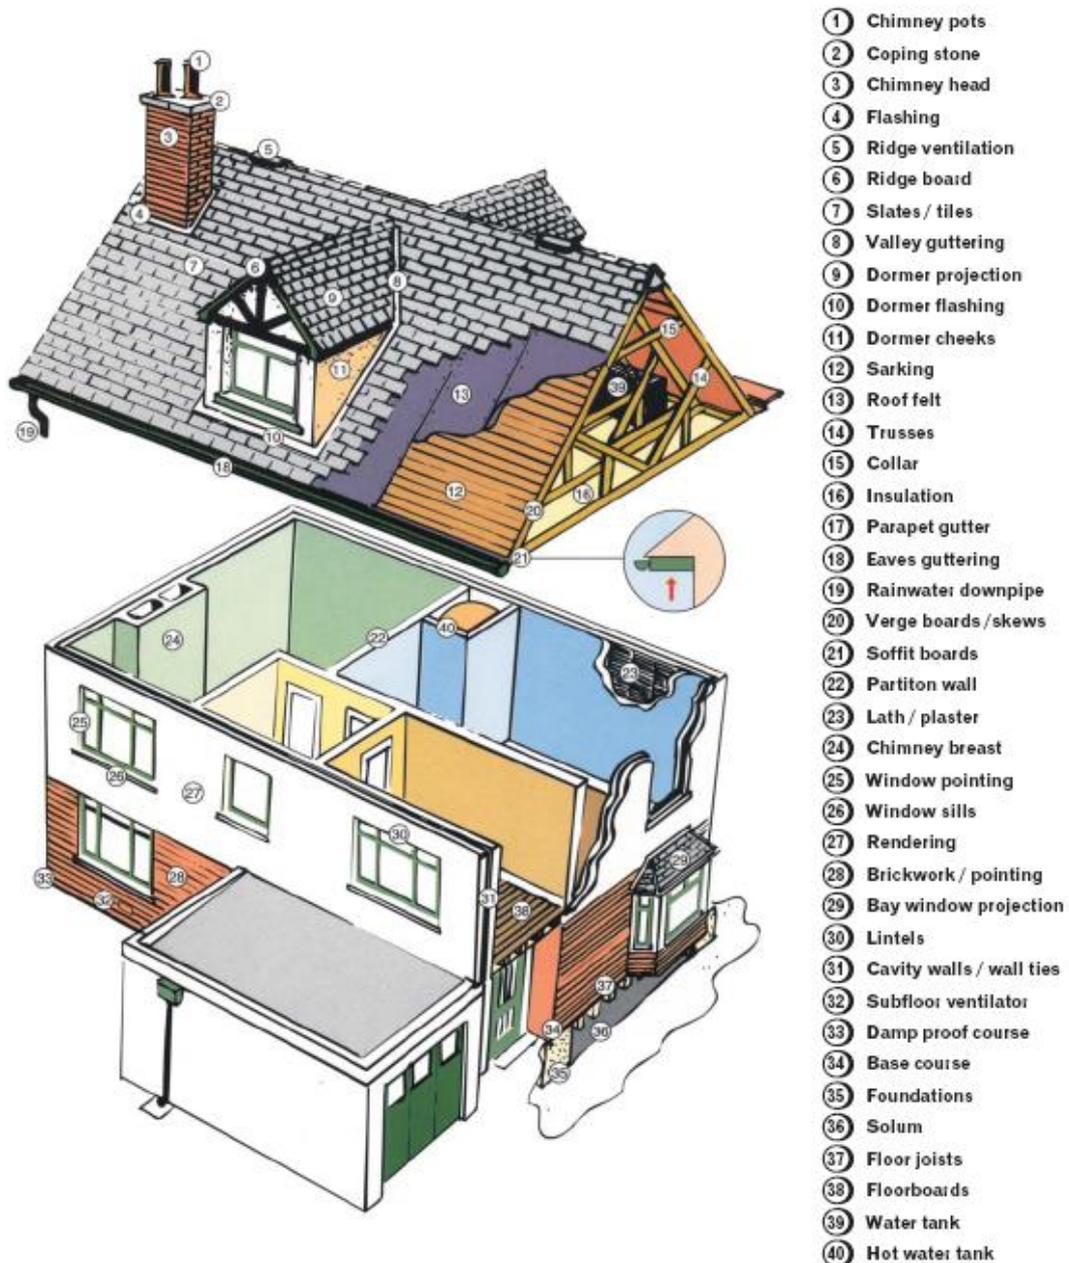
**Sectional Diagram showing elements of a typical house**

Reference may be made in this report to some or all of the above component parts of the property. This diagram may assist you in locating and understanding these items.

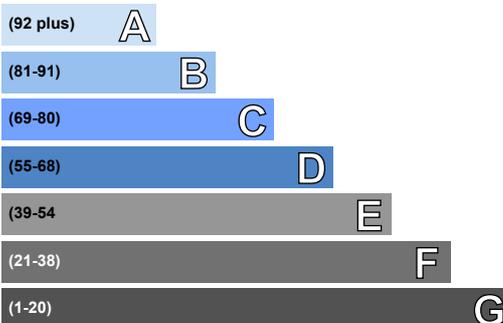
## Environmental Impact (CO<sub>2</sub>) Rating

Very environmentally friendly - lower CO<sub>2</sub> emissions

Current	Potential
58	72
