Single Survey

40 Rose Street Thurso KW14 7HN

survey report on:

Customer	Estate of the late Sinclair Leitch
Customer Address	
Date of Inspection	4 th October 2023
Prepared by	Keith J Bowman BSc MRICS Registered Valuer

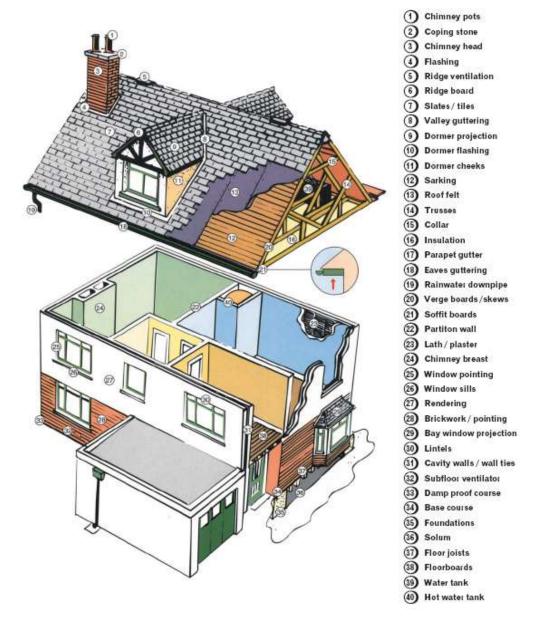
Sectional Diagram showing elements of a typical house

Reference may be made in this report to some or all of the above component parts of the property. This diagram may assist you in locating and understanding these items.
