## Single Survey

**1 Sir Georges Street  
Thurso  
Caithness  
KW14 7AW**

survey report on :

<b>Customer</b>	Clare Thoms
<b>Customer Address</b>	
<b>Date of Inspection</b>	8 <sup>th</sup> January 2024
<b>Prepared by</b>	Keith Bowman BSc MRICS Registered Valuer

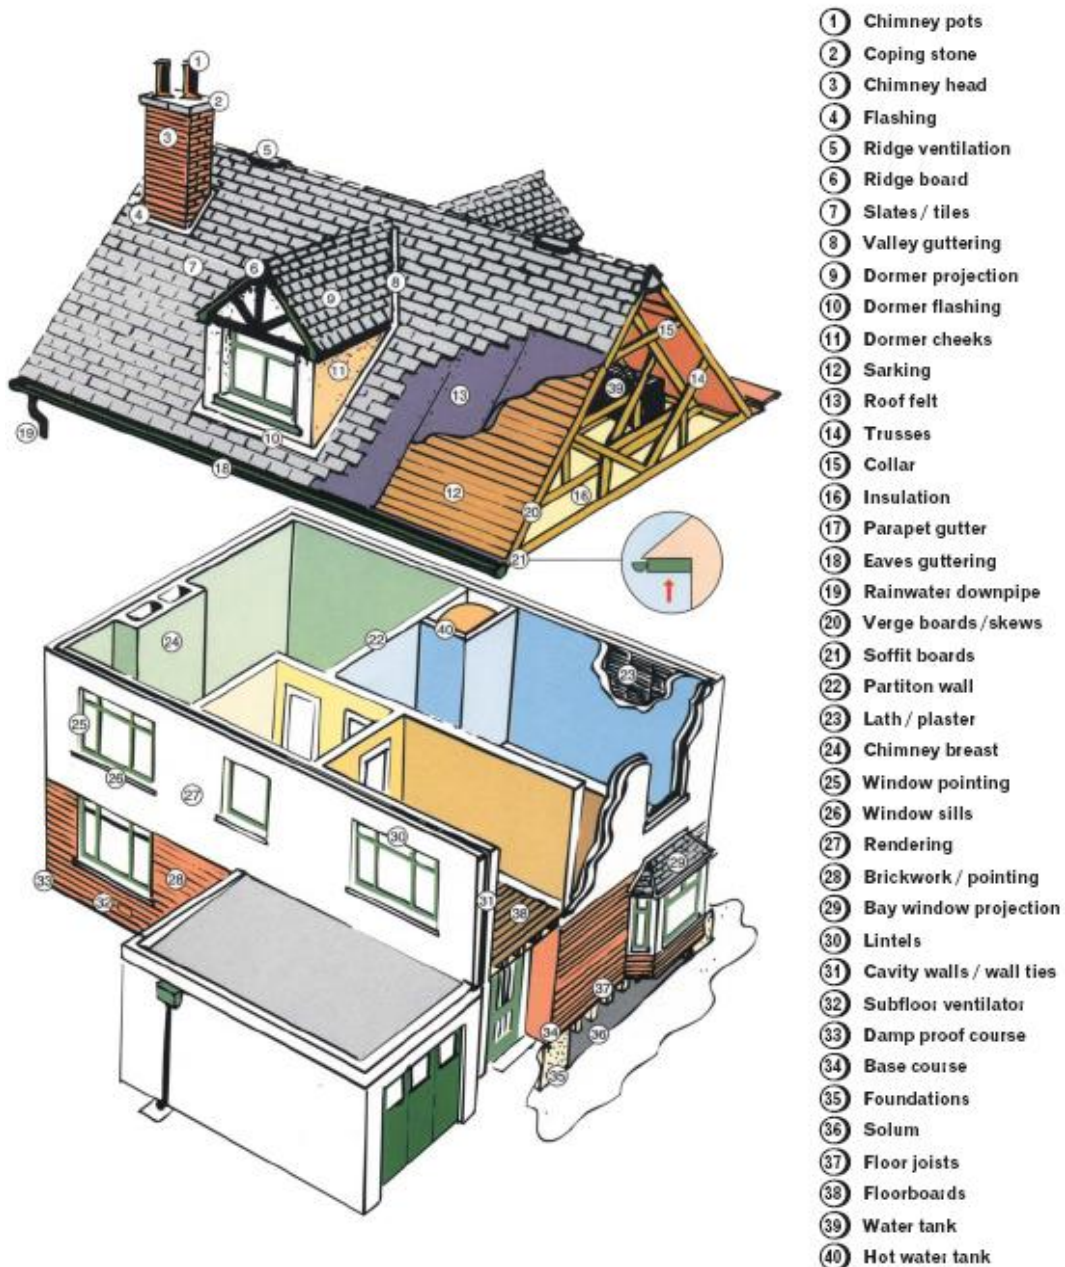
**Sectional Diagram showing elements of a typical house**

Reference may be made in this report to some or all of the above component parts of the property. This diagram may assist you in locating and understanding these items.

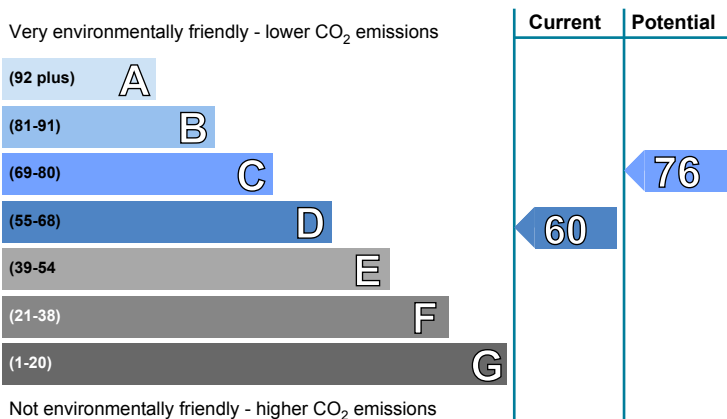
## Environmental Impact (CO<sub>2</sub>) Rating

This graph shows the effect of your home on the environment in terms of carbon dioxide (CO<sub>2</sub>) emissions. The higher the rating, the less impact it has on the environment.
