Single Survey

Caniswick Cottage Auckengill Wick KW1 4XP

survey report on :

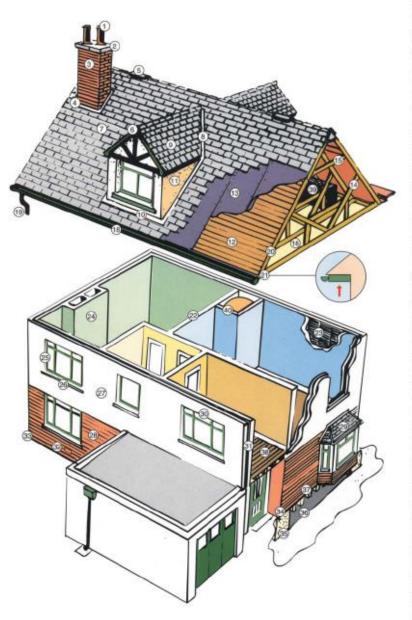
Sectional Diagram showing elements of a typical house

Reference may be made in this report to some or all of the above component parts of the property. This diagram may assist you in locating and understanding these items.
