# **Single Survey**

5 Burnside Scrabster Thurso Caithness KW14 7UG

# survey report on :

Customer	Executry of the Late Alastair Fraser
Customer Address	
Date of Inspection	6 <sup>th</sup> November 2024
L	
Prepared by	Keith Bowman BSc MRICS Registered Valuer

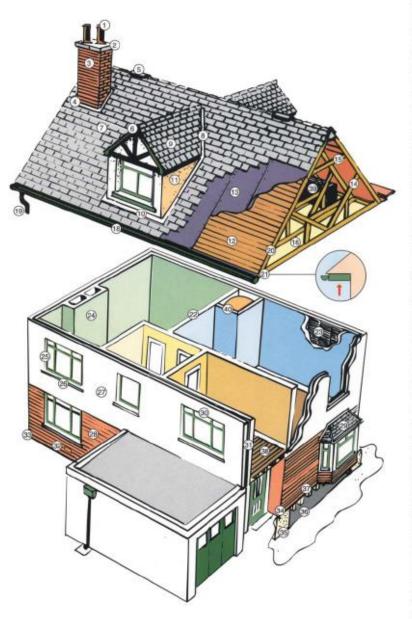
# Sectional Diagram showing elements of a typical house

Reference may be made in this report to some or all of the above component parts of the property. This diagram may assist you in locating and understanding these items.
