Home Report

2 MORAY STREET
WICK
KW1 5QF

Energy Performance Certificate (EPC)

Single Survey

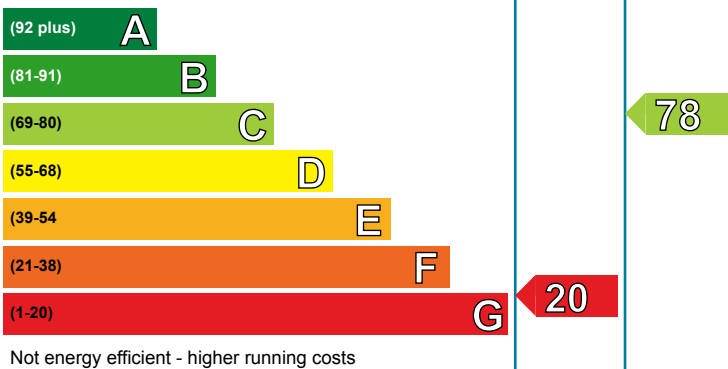
Energy Efficiency Rating

This graph shows the current efficiency of your home, taking into account both energy efficiency and fuel costs. The higher this rating, the lower your fuel bills are likely to be.

Your current rating is **band G (20)**. The average rating for EPCs in Scotland is **band D (61)**.

The potential rating shows the effect of undertaking all of the improvement measures listed within your recommendations report.

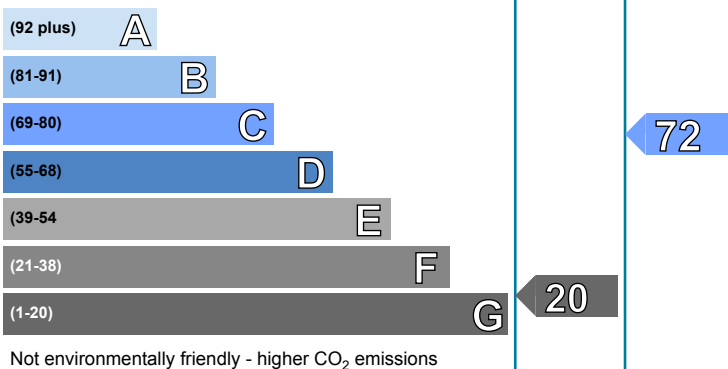
Environmental Impact (CO₂) Rating

This graph shows the effect of your home on the environment in terms of carbon dioxide (CO₂) emissions. The higher the rating, the less impact it has on the environment.

Your current rating is **band G (20)**. The average rating for EPCs in Scotland is **band D (59)**.

The potential rating shows the effect of undertaking all of the improvement measures listed within your recommendations report.

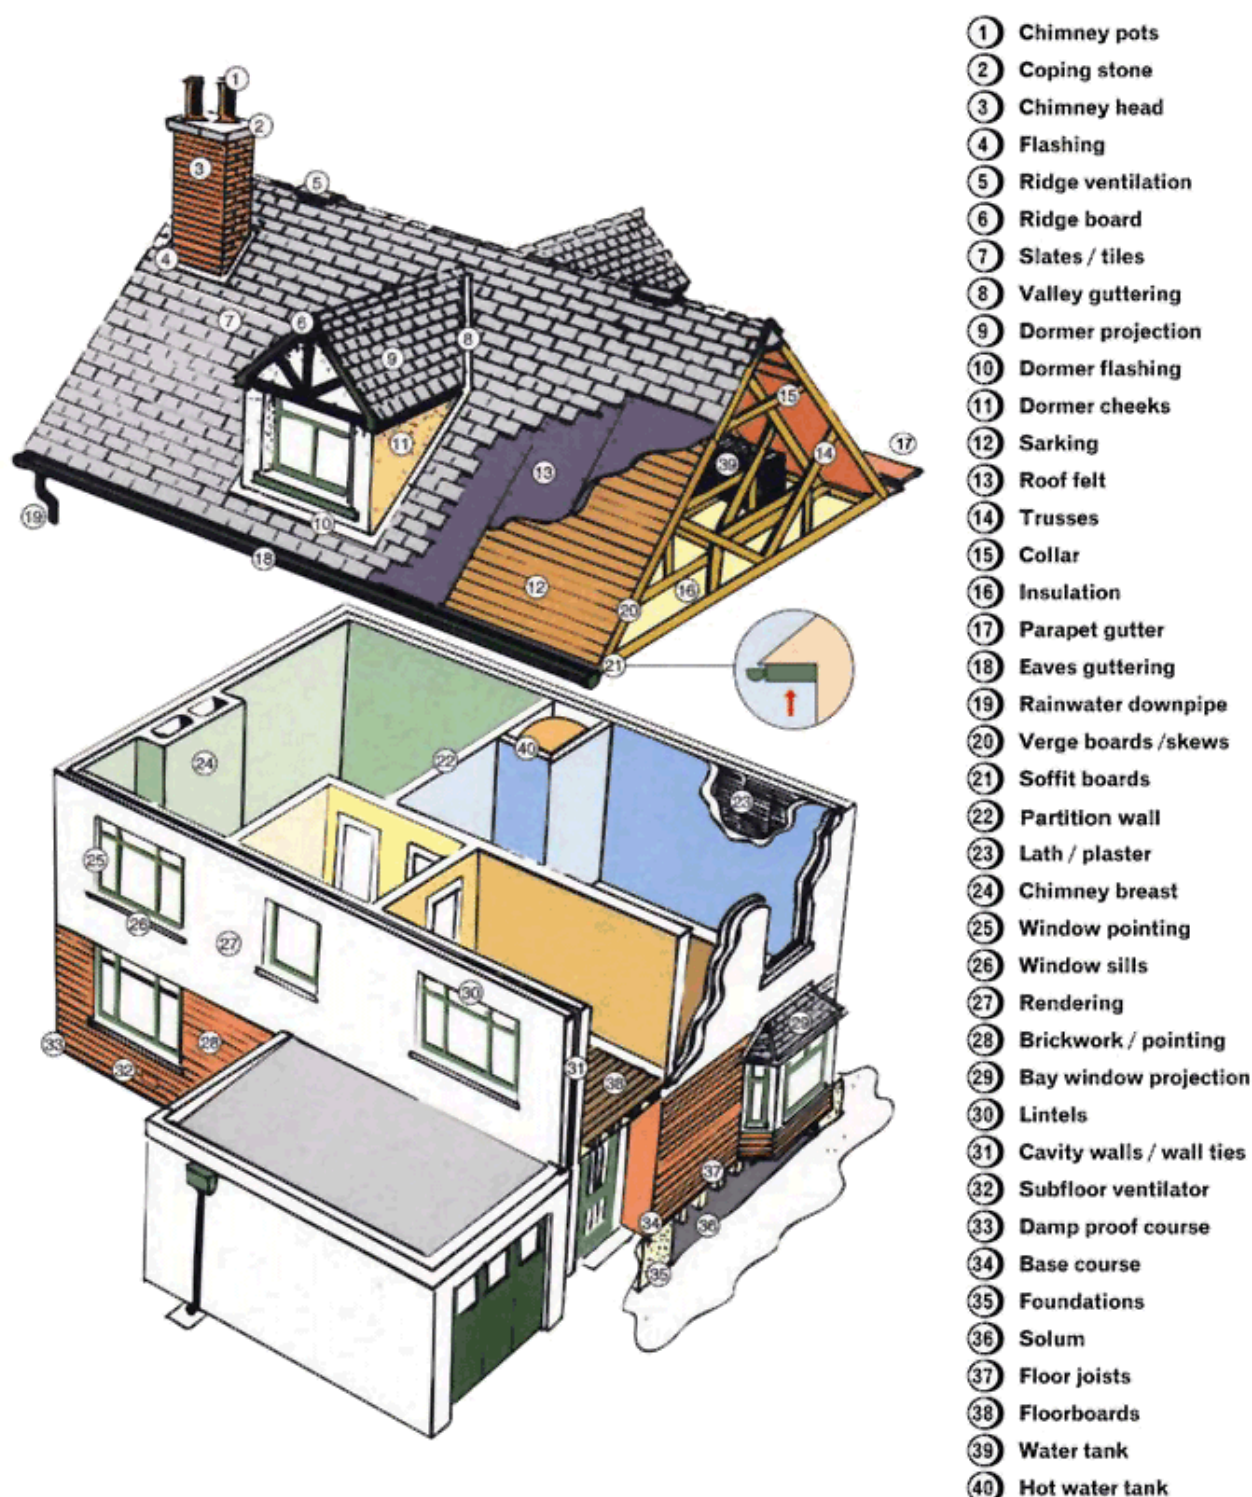
Sectional Diagram showing elements of a typical house

Reference may be made in this report to some or all of the above component parts of the property. This diagram may assist you in locating and understanding these items.
